# Manhole Inspection Summary

## Manhole # S13KK1025MH

Insp Date: **12/14/06 9:20 AM**

**Location** Address: **3029 WYLIE AVE**

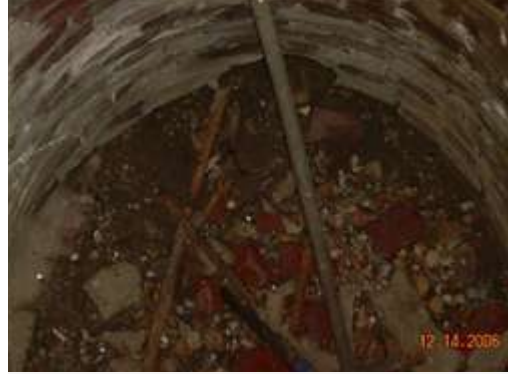
Top View

Barrel infiltration. Channel debris

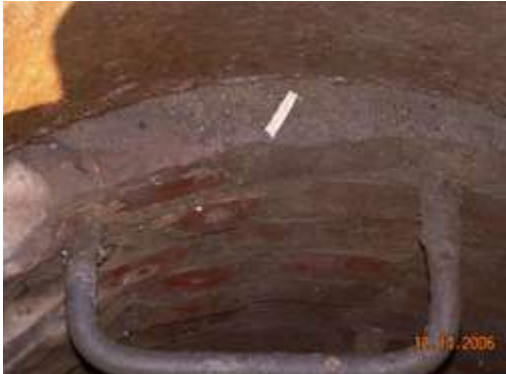
Defect

Frame leaks. Frame offset. Adjustment infiltration.

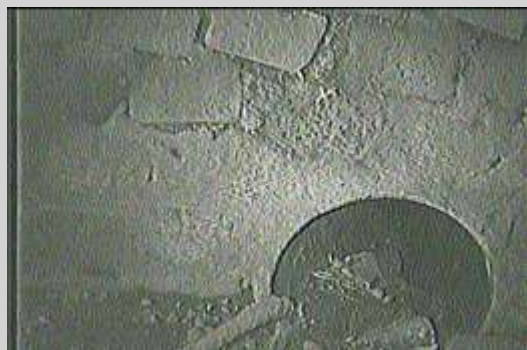
Pipe Out @ 12 O'Clock

Deposits: ☐ None ☐ Mud ☐ Sludge ☒ **Debris** ☐ Grease

Silt Depth: **2** (in.)

Deposits Extent: **Light**
